**Flood Control Project Maintenance
Levee Inspections**
LMA District Cover Sheet
Spring 2019 Levee Inspection Results

Levee District No. 0001 (Glenn County)

Spring 2019 Levee Inspection Results

Waterway			Bank	Unit Miles
Unit No. 01 Sacramento River			Right	12.23
	Spring (March - May)	Summer (June - August)	(September - November) Fall	Winter (December - February)
Unit Maintenance Rating (Fall Only)				
Date of Inspection	4/26/2019 - 4/26/2019			
DWR Inspector	Makar Sokol			
Accompanied By	Nick Henning			
	Nick Perez

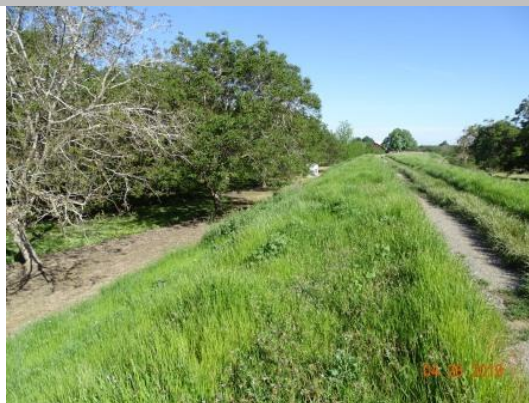
Photo 1 of 1 : SP_2019_LD0001G_432_2_20190429_00105.jpg

LM Start	0.01	Rating **	M	Issue No.	2
LM End	1.22	Issue Type +	Ma	Location *	LS
Category	Earthen Levee			GPS Latitude/Longitude	
				Start	End
Item	Vegetation			39.477246 °	39.493619 °
				-122.017628 °	-122.018741 °
DWR ID	DWR_LD0001G_01_s_2012_2				
Comment Code					
V1 : Control annual grass and weeds on the levee slopes and easements.					
Inspector Comment

View of the vegetation on the landside slope. Spring 2019.

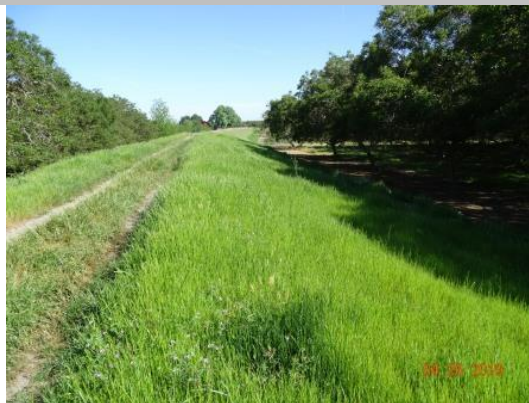
Photo 1 of 1 : SP_2019_LD0001G_432_3_20190429_00106.jpg

LM Start	0.01	Rating **	M	Issue No.	3
LM End	1.22	Issue Type +	Ma	Location *	WS
Category	Earthen Levee			GPS Latitude/Longitude	
				Start	End
Item	Vegetation			39.477246 °	39.493661 °
				-122.017630 °	-122.018703 °
DWR ID	DWR_LD0001G_01_s_2012_3				
Comment Code					
V1 : Control annual grass and weeds on the levee slopes and easements.					
Inspector Comment

View of the vegetation on the waterside slope. Spring 2019.

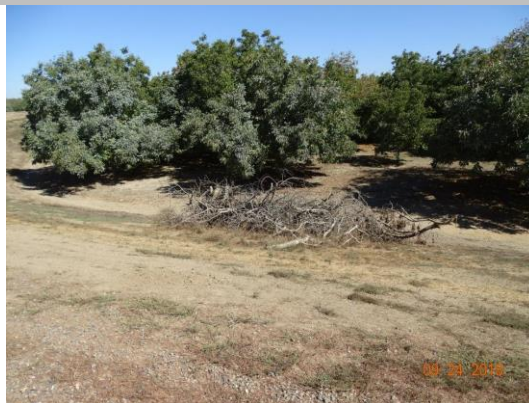
Photo 1 of 1 : SP_2019_LD0001G_432_62_20190313_00023.jpg

LM Start	0.83	Rating **	M	Issue No.	62
LM End	0.83	Issue Type +	En	Location *	WS
Category	Earthen Levee			GPS Latitude/Longitude	
				Start	End
Item	Encroachments			39.488445 °	39.488445 °
				-122.020305 °	-122.020305 °
DWR ID	DWR_LD0001G_01_f_2018_62				
Comment Code					
PR : Prunings					
Inspector Comment					
Prunings should be removed from the waterside toe.

View of the prunings along the waterside toe.

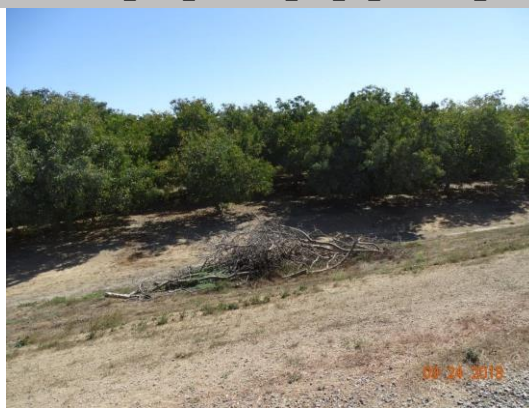
Photo 1 of 1 : SP_2019_LD0001G_432_61_20190313_00022.jpg

LM Start	0.92	Rating **	M	Issue No.	61
LM End	0.92	Issue Type +	En	Location *	WS
Category	Earthen Levee			GPS Latitude/Longitude	
				Start	End
Item	Encroachments			39.489718 °	39.489718 °
				-122.020650 °	-122.020650 °
DWR ID	DWR_LD0001G_01_f_2018_61				
Comment Code					
PR : Prunings					
Inspector Comment					
Prunings should be removed from the waterside toe.

View of the prunings along the waterside toe.

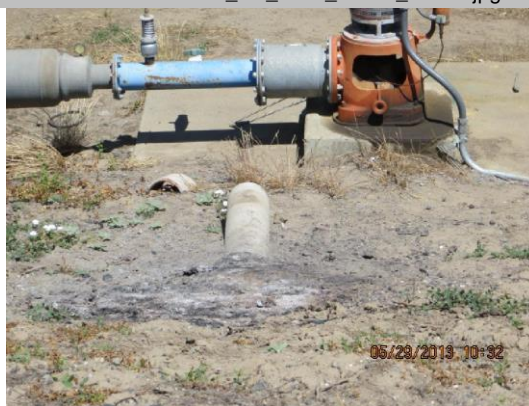
Photo 2 of 3 : UCIP_SP_2019_14332_23581.jpg

Pipe next to pump at LS toe.

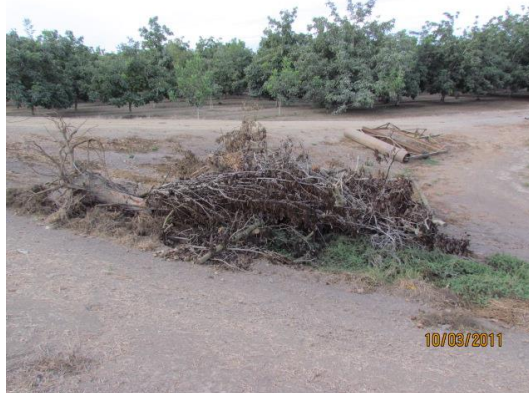
Photo 1 of 1 : SP_2019_LD0001G_432_16_20190313_00007.jpg

LM Start	3.19	Rating **	M	Issue No.	16
LM End	3.19	Issue Type +	En	Location *	LS
Category	Earthen Levee			GPS Latitude/Longitude	
				Start	End
Item	Encroachments			39.514709 °	39.514709 °
				-122.010515 °	-122.010515 °
DWR ID	DWR_LD0001G_01_s_2012_16				
Comment Code					
PR : Prunings					
Inspector Comment					
Prunings should be removed from the landside toe.

View of the pruning pile along the LS toe.

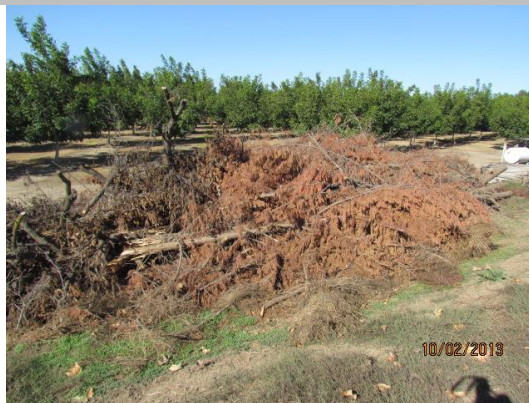
Photo 1 of 1 : SP_2019_LD0001G_432_56_20190313_00018.jpg

LM Start	3.63	Rating **	M	Issue No.	56
LM End	3.63	Issue Type +	En	Location *	LS
Category	Earthen Levee			GPS Latitude/Longitude	
				Start	End
Item	Encroachments			39.520623 °	39.520623 °
				-122.010457 °	-122.010457 °
DWR ID	DWR_LD0001G_01_f_2013_56				
Comment Code					
PR : Prunings					
Inspector Comment					
Prunings should be removed from the landside slope and toe.

View of the prunings and limbs along the slope of the levee.

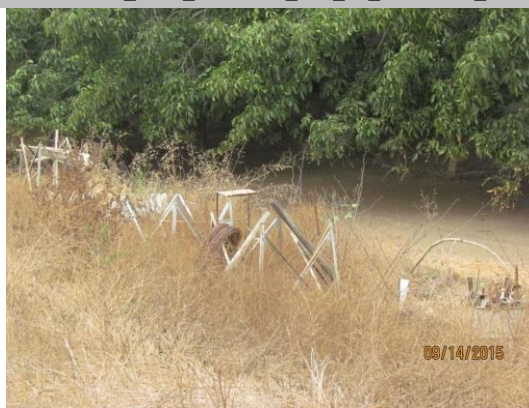
Photo 1 of 1 : SP_2019_LD0001G_432_23_20190313_00009.jpg

LM Start	3.86	Rating **	M	Issue No.	23
LM End	3.86	Issue Type +	En	Location *	LS
Category	Earthen Levee			GPS Latitude/Longitude	
				Start	End
Item	Encroachments			39.523660 °	39.523660 °
				-122.010863 °	-122.010863 °
DWR ID	DWR_LD0001G_01_s_2012_23				
Comment Code					
EQ : Equipment					
Inspector Comment					
Remove equipment from the landside toe.

View of the equipment along the landside toe.

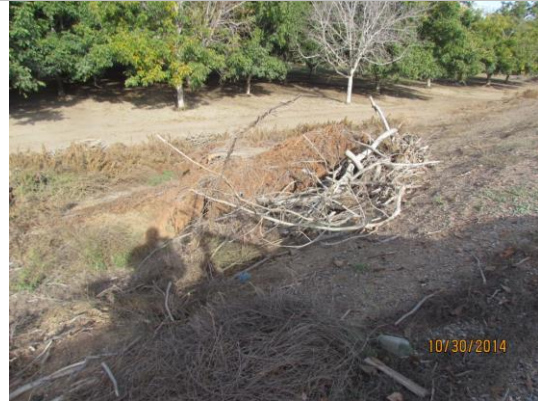
Photo 1 of 1 : SP_2019_LD0001G_432_52_20190313_00016.jpg

LM Start	3.88	Rating **	M	Issue No.	52
LM End	3.88	Issue Type +	En	Location *	LS
Category	Earthen Levee			GPS Latitude/Longitude	
				Start	End
Item	Encroachments			39.523855 °	39.523855 °
				-122.010762 °	-122.010762 °
DWR ID	DWR_LD0001G_01_f _ 2014_52				
Comment Code					
PR : Prunings					
Inspector Comment					
Prunings should be removed from the landside toe.

View of the prunings along the landside toe.

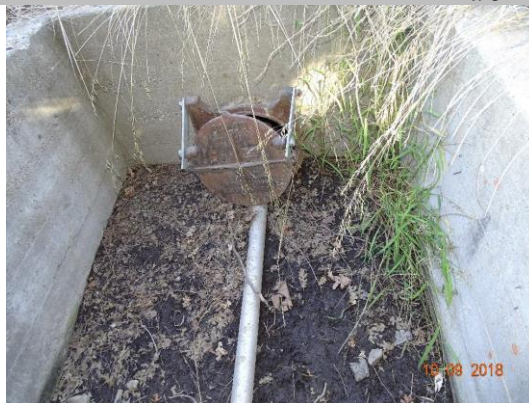
Photo 2 of 3 : UCIP_SP_2019_53006_78124.jpg

LM Start	3.98	Rating **	U	Issue No.	404 (cont)
LM End	3.98	Issue Type +	Ma	Location *

3-inch pipe obstructs flap gate from complete closing.

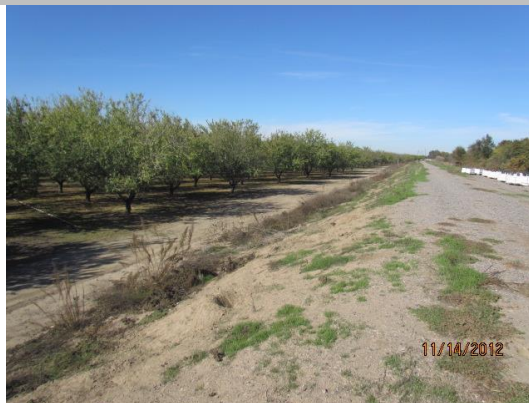
Photo 1 of 1 : SP_2019_LD0001G_432_7_20190313_00003.jpg

LM Start	5.08	Rating **	U	Issue No.	7
LM End	5.17	Issue Type +	Ma	Location *	LS
Category	Earthen Levee			GPS Latitude/Longitude	
				Start	End
Item	Animal Control			39.534741 °	39.536013 °
				-121.996024 °	-121.996702 °
DWR ID	DWR_LD0001G_01_f_2012_7				
Comment Code					
A3 : No rodents visible, but rodent burrows visible; need to backfill and compact or grout burrows.					
Inspector Comment

View of the rodent hole along the levee slope.

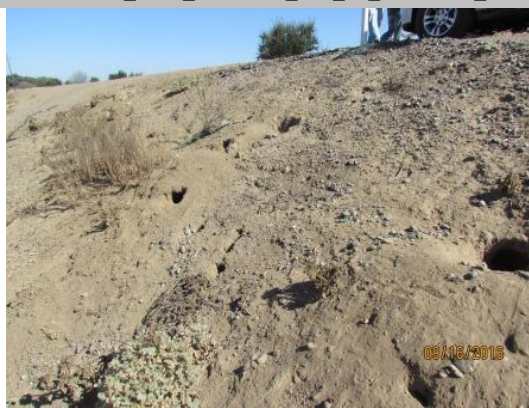
Photo 1 of 1 : SP_2019_LD0001G_432_67_20190313_00025.jpg

LM Start	5.22	Rating **	U	Issue No.	67
LM End	5.22	Issue Type +	Ma	Location *	LS
Category	Earthen Levee			GPS Latitude/Longitude	
				Start	End
Item	Animal Control			39.536750 °	39.536750 °
				-121.997090 °	-121.997090 °
DWR ID	DWR_LD0001G_01_s_2016_67				
Comment Code					
A3 : No rodents visible, but rodent burrows visible; need to backfill and compact or grout burrows.					
Inspector Comment

View of the rodent holes along the landside slope.

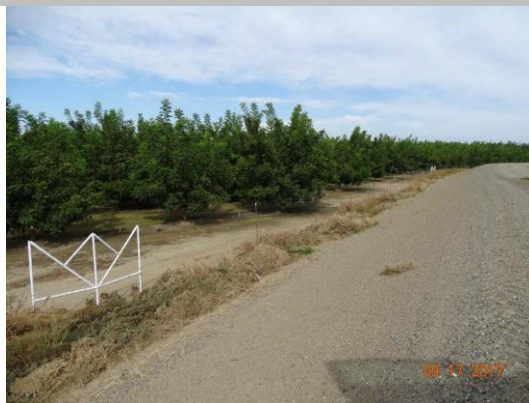
Photo 1 of 1 : SP_2019_LD0001G_432_78_20190313_00032.jpg

LM Start	5.74	Rating **	M	Issue No.	78
LM End	5.89	Issue Type +	En	Location *	LS
Category	Earthen Levee			GPS Latitude/Longitude	
				Start	End
Item	Encroachments			39.543737 °	39.545868 °
				-122.000718 °	-122.000948 °
DWR ID	DWR_LD0001G_01_f_2017_78				
Comment Code					
FE : Fence					
Inspector Comment					
The fence should be removed from the landside toe.

View of the fence along the landside toe.

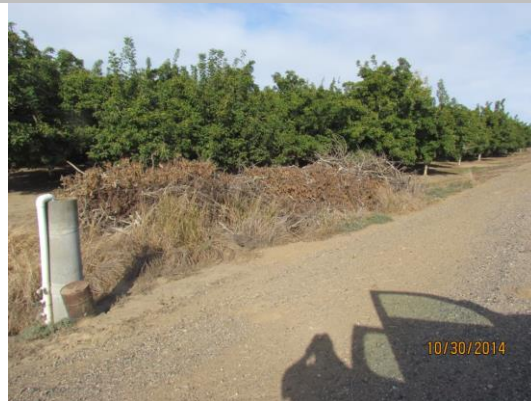
Photo 1 of 1 : SP_2019_LD0001G_432_54_20190313_00017.jpg

LM Start	5.90	Rating **	M	Issue No.	54
LM End	5.90	Issue Type +	En	Location *	LS
Category	Earthen Levee			GPS Latitude/Longitude	
				Start	End
Item	Encroachments			39.545992 °	39.545992 °
				-122.001180 °	-122.001180 °
DWR ID	DWR_LD0001G_01_f_2014_54				
Comment Code					
PR : Prunings					
Inspector Comment					
Prunings should be removed from the landside toe.

View of the prunings along the landside toe.

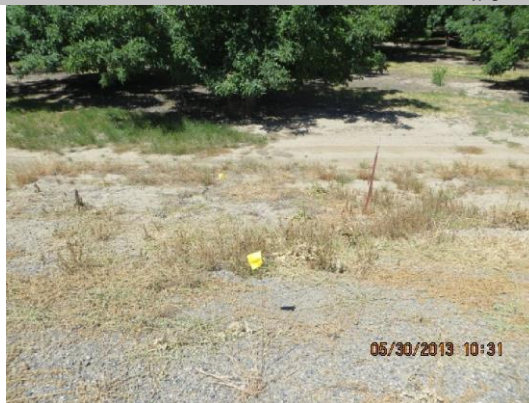
Photo 1 of 2 : UCIP_SP_2019_14352_23609.jpg

Gasline flags on LS slope.

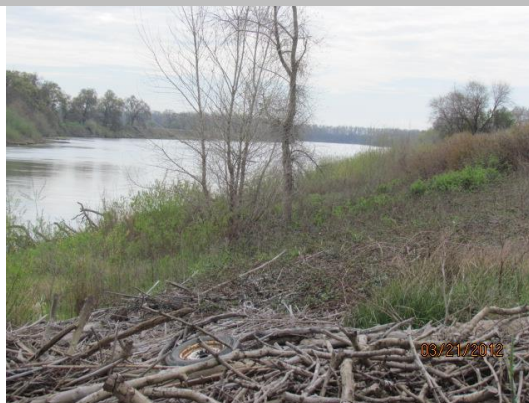
Photo 1 of 1 : SP_2019_LD0001G_432_10_20190313_00005.jpg

LM Start	6.38	Rating **	A/W	Issue No.	10
LM End	6.64	Issue Type +	Ob	Location *	WS
Category	Earthen Levee			GPS Latitude/Longitude	
				Start	End
Item	Vegetation			39.552691 °	39.556459 °
				-122.003063 °	-122.003831 °
DWR ID	DWR_LD0001G_01_s_2012_10				
Comment Code					
V8 : Environmental Requirements.					
Inspector Comment

View of the Army Corps of Engineers mitigation site.

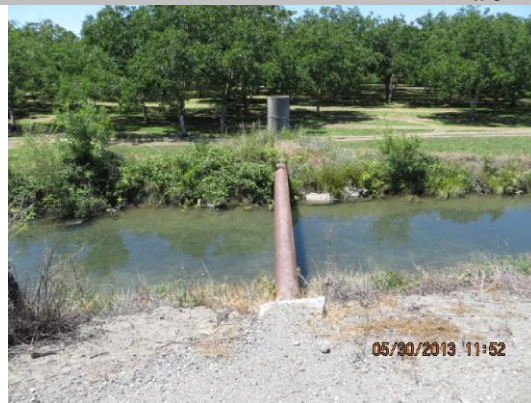
Photo 1 of 3 : UCIP_SP_2019_14384_23664.jpg

Pipe on LS toe with concrete standpipe visible.

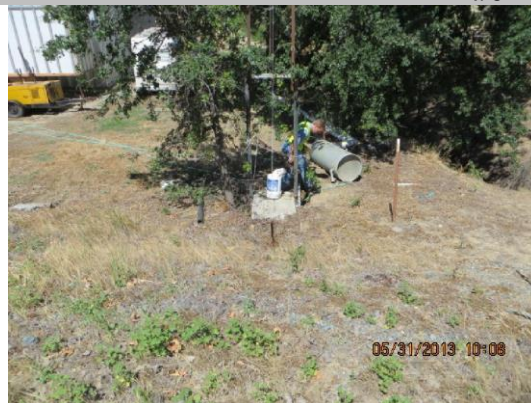
Photo 1 of 3 : UCIP_SP_2019_16204_27330.jpg

Pipe visible next to well with bucket over standpipe.

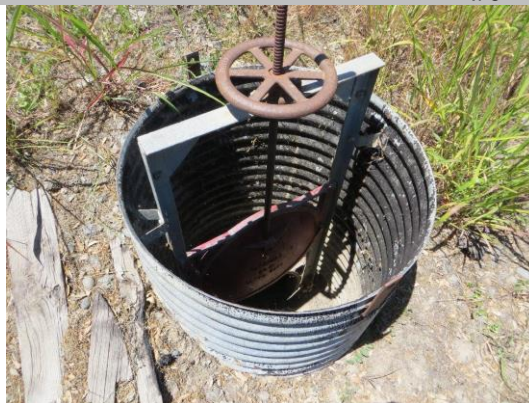
Photo 2 of 3 : UCIP_SP_2019_14570_24028.jpg

Slidegate in 36-inch CMP riser on WS slope.
